Helpful Hints

Spark Plug Faces: Recognise and rectify your automotive problem

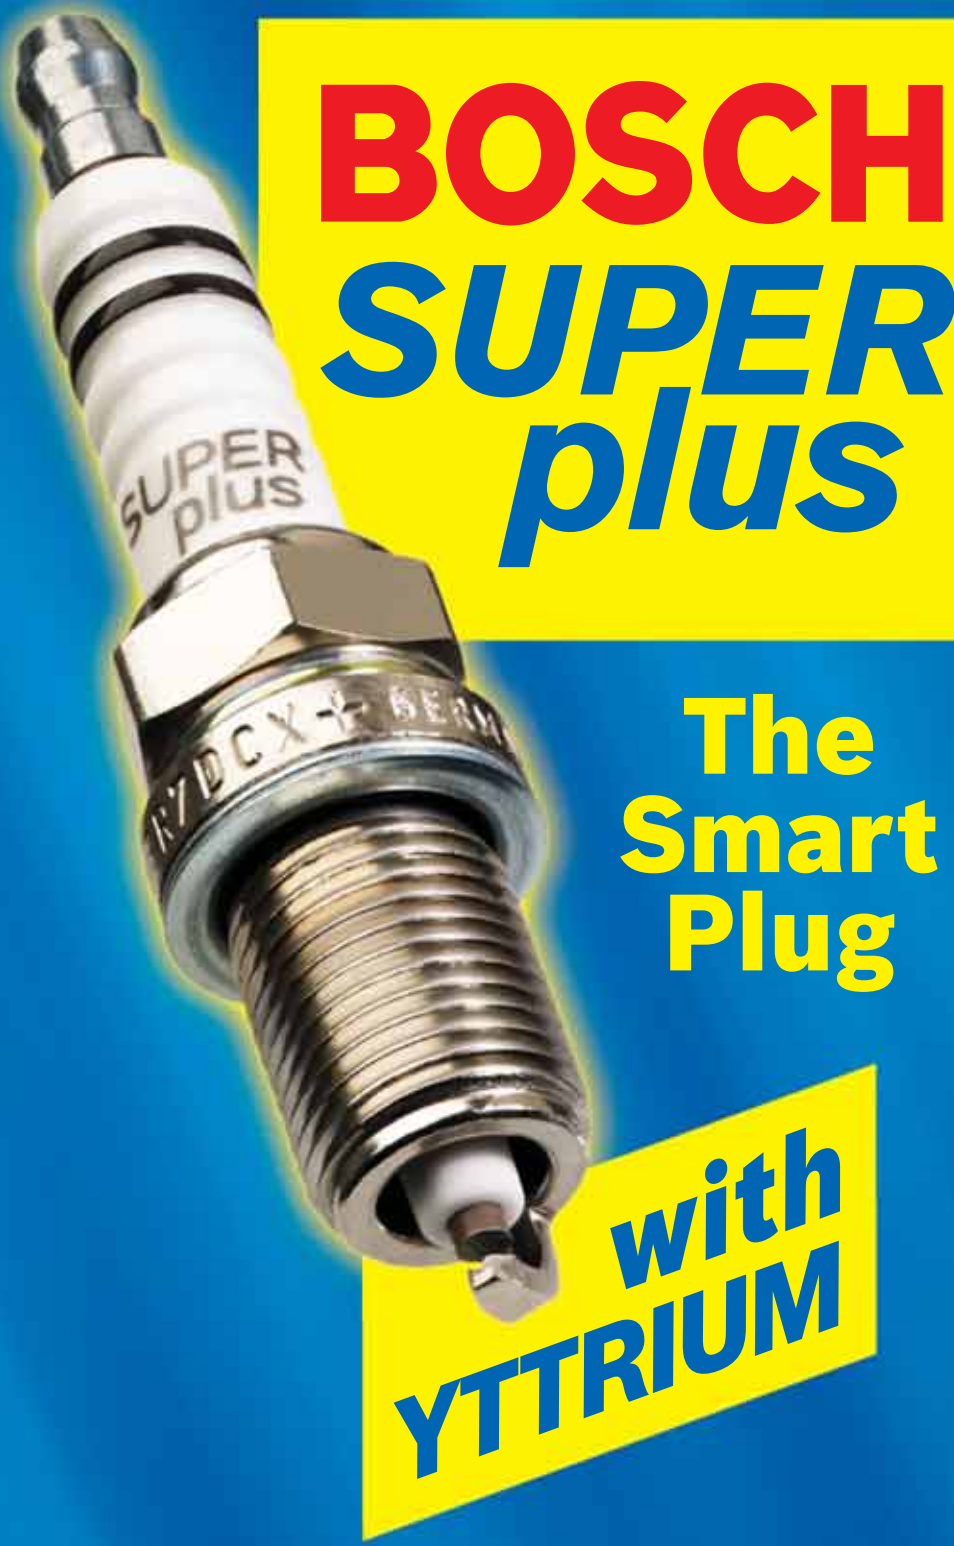
1, 2
Normal condition
Insulator nose greyish-yellow to russet brown. Engine is in order. Heat range of plug correct. Mixture setting and ignition timing are correct, no misfiring, cold starting device functions correctly.
No deposits from fuel additives containing lead or from alloying constituents in the engine oil.
No overheating.

3, 4
Soot - carbon fouled
Insulator nose, electrodes and spark-plug shell covered with velvet-like, dull black soot deposits.
Cause: incorrect mixture setting (carburettor, fuel injection): mixture too rich, air filter very dirty, automatic choke not in order or manual choke pulled too long, mainly short distance driving, spark plug too cold, heat range code number too low
Effect: misfiring, poor cold-starting performance.
Remedy: set mixture and cold-starting device correctly, check air filter.

5, 6
Oil-fouled
Insulator nose electrodes and spark-plug shell covered with shiny soot or carbon residue.
Cause: too much oil in combustion chamber. Oil level too high, badly worn piston rings, cylinders and valve guides. In two stroke gasoline engines, too much oil in mixture.
Effect: misfiring, poor starting performance.
Remedy: overhaul engine, correct fuel-oil mixture, new spark plugs.

7, 8
Lead deposits
In places the insulator nose is glazed brownish yellow; this may also tend towards green.
Cause: fuel additives which contain lead. The glaze appears in the case of heavy engine loading after lengthy part-load operation.
Effect: under heavy loading deposits become electrically conductive and cause misfiring.
Remedy: new spark plugs, cleaning is pointless.

9, 10
Heavy lead deposits.
In places the insulator nose is thickly glazed brownish-yellow, this may also tend towards green.
Cause: fuel additives which contain lead. The glaze appears in the case of heavy engine loading after lengthy part-load operation.
Effect: under heavy loading, deposits become electrically conductive and cause misfiring.
Remedy: new spark plugs, cleaning is pointless.

11, 12
Formation of ash
Heavy ash deposits from oil and fuel additives on the insulator nose, in the scavenging area and on the ground electrode. The structure of the ash is loose to cinder-like.
Cause: alloying constituents, in particular from oil, can deposit this ash in the combustion chamber and on the spark-plug face.
Effect: can lead to auto ignition with loss of power and engine damage.
Remedy: repair engine. New spark plugs. Possibly use other oil.

13
Partially melted centre electrode
Centre electrode partially melted, blistered, spongy insulator tip.
Cause: overheating due to auto-ignition, e.g. due to over-advanced ignition timing, combustion deposits in combustion chamber, defective valves, defective ignition distributor, inadequate fuel quality, heat range possibly too low.
Effect: misfiring, loss of power (engine damage)
Remedy: check engine, ignition and mixture formation. New spark plugs with correct heat range.

15
Partially melted electrodes
Cauliflower-like appearance of the electrodes. Possibly deposition of foreign matter.
Cause: overheating due to auto-ignition, e.g. due to over-advanced ignition timing, combustion deposits in combustion chamber, defective valves, defective ignition distributor, inadequate fuel quality.
Effect: loss of power prior to complete failure (engine damage)
Remedy: check engine, ignition and mixture formation. New spark plugs

17
Heavy wear on ground electrode.
Cause: aggressive fuel and oil additives. Unfavourable influence of gas turbulence in the combustion chamber, possibly caused by deposits. Knocking. No overheating.
Effect: misfiring particularly when accelerating (ignition voltage no longer sufficient for large electrode gap). Poor starting performance.
Remedy: new spark plugs.

18
Insulator nose breakage
Cause: mechanical damage due to being struck or dropped or due to pressure on the centre electrode when improperly handled. In borderline cases – particularly when the spark plug has been in use for too long – the insulator nose may be cracked by deposits between the centre electrode and the insulator nose and by corrosion of the centre electrode.
Effect: misfiring. Spark jumps across at points which are not reliably reached by the mixture.
Remedy: new spark plugs
